## Technical report on Anode part #

As per our Commercial Dept. request, we verified installation for our part # on Mercury sterndrive Bravo III-2004 We took two genuine parts

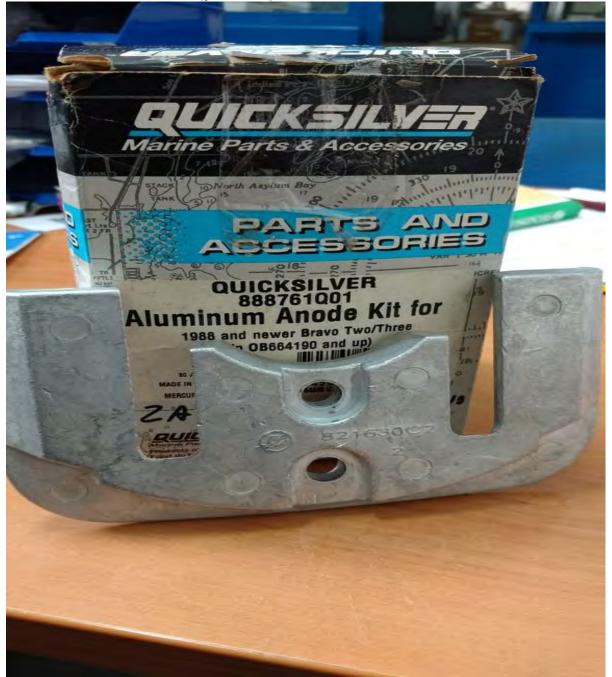
## SAMPLE/GENUINE PART "A" (year 2012)

As you can see, the two genuine parts have significant differences because of significant changes made by Mercury on the frame; these changes have been confirmed by one of authorized Mercury dealers where we made the installation tests.

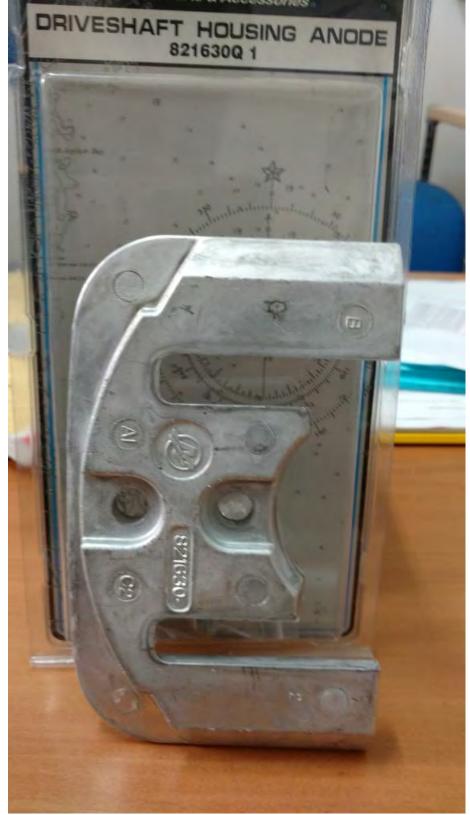
Second genuine part: SAMPLE/GENUINE PART "B" (year 2016)

At the end of 2015, Mercury fixed the problem with a new anode (as shown on the above picture SAMPLE "B") but they kept the same genuine part number.

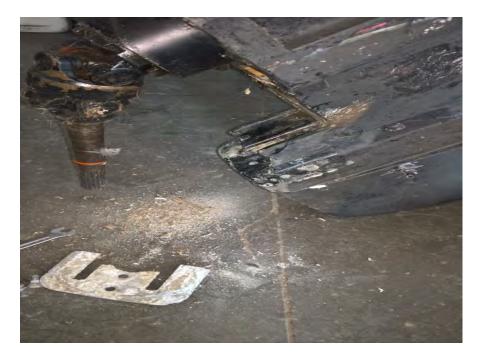
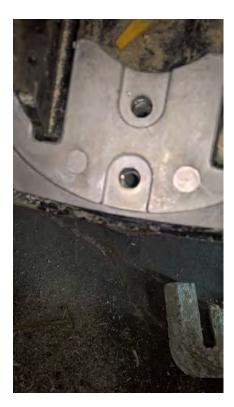
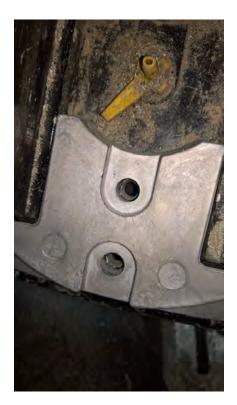
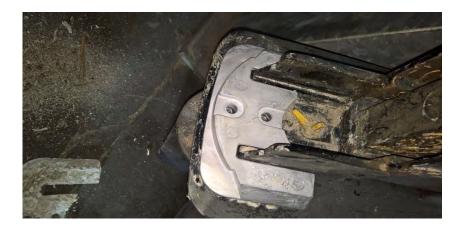
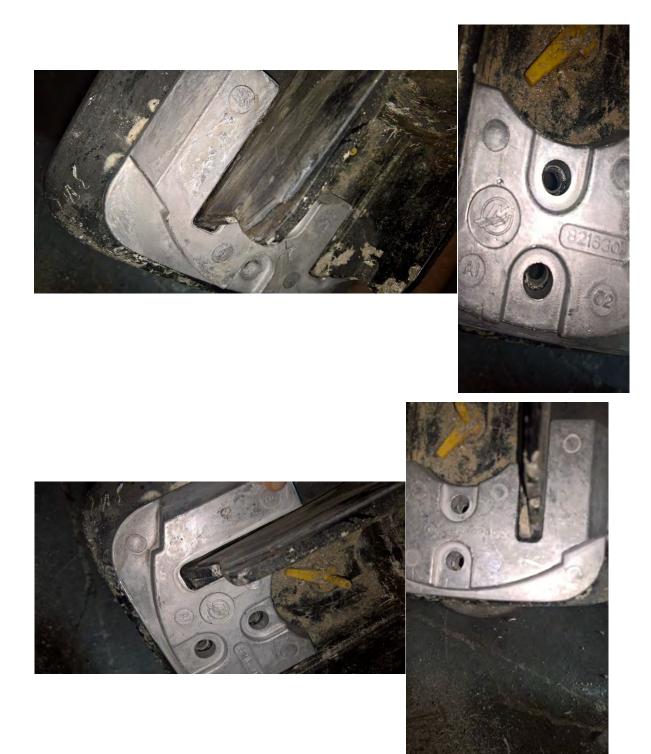
Technical spec. : Mercury Bravo III-2004 engine; manufacturing year 2010

As shown in the pictures, all genuine parts and O Bravo III-2004 sterndrive, year 2010

anodes were installed with no problem on the

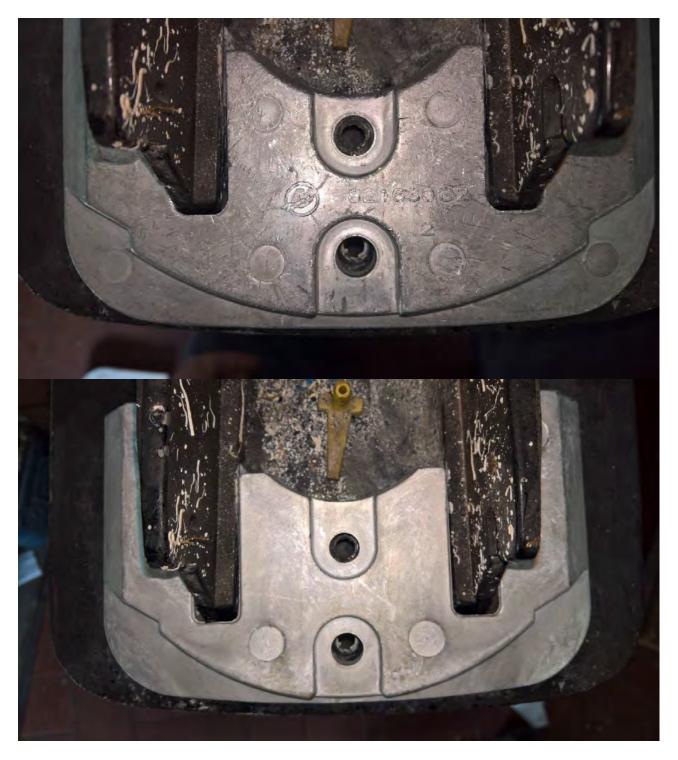
We made the same installation test on a Bravo III-2004 year 2014

The genuine part SAMPLE "B" (year 2016) was installed with no problem since the holes are perfectly aligned.

We noticed that SAMPLE "A" and Tecnoseal anode, because of the recent modification on the sterndrive can be installed forcing them.

The Mercury technical manager suggested us to install our part # as shown on the "installation scheme".
