## Technical report on Anode part #

As per our Commercial Dept. request, we verified installation for our part # on Mercury sterndrive Bravo III-2004 We took two genuine parts

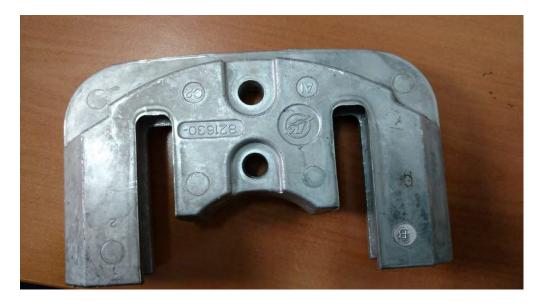
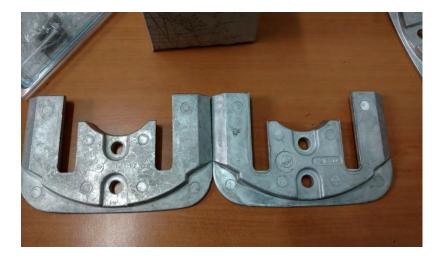
As you can see, the two genuine parts have significant differences because of significant changes made by Mercury on the frame; these changes have been confirmed by one of authorized Mercury dealers where we made the installation tests.

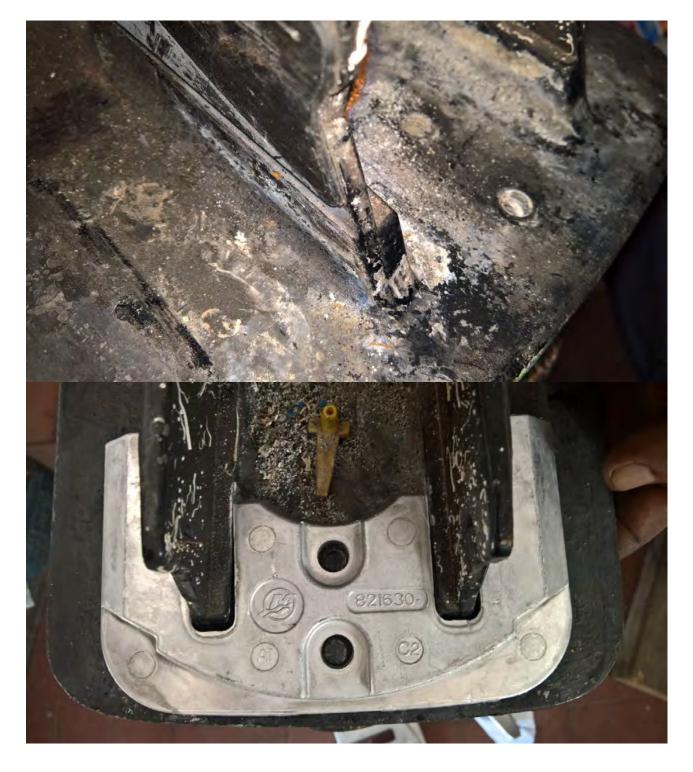
As shown in the pictures, all genuine parts and O Bravo III-2004 sterndrive, year 2010

anodes were installed with no problem on the
